# Damage characterization of concrete panels due to impact loading by motionless X-ray laminography

Fariborz Vossoughi · Claudia P. Ostertag ·  
Paulo J. M. Monteiro · Richard D. Albert

Received: 29 June 2006 / Accepted: 28 July 2006  
© Springer Science+Business Media, LLC 2007

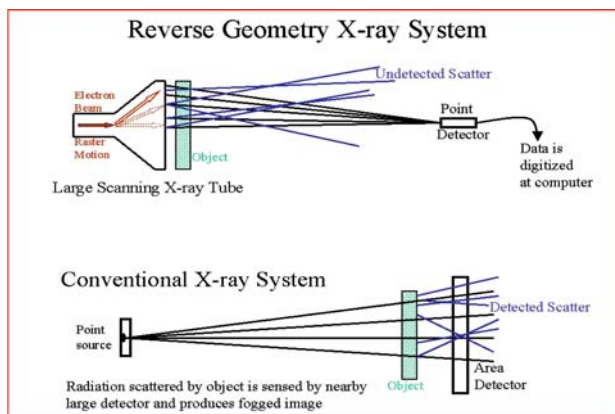
**Fig. 1** Reverse geometry X-ray system versus conventional X-ray system

The MLX system, on the other hand, is motionless. The need for moving parts and the need for critical alignment is eliminated by utilizing a different geometry of the detection system. MLX is based on reverse geometry X-ray (RGX)<sup>®</sup> radiography [2]. The difference between conventional X-ray radiography and RGX is schematically illustrated in Fig. 1. The reverse geometry shows the object close to the source instead of close to the detector as in conventional systems. The X-rays are produced by a scanning beam generated in a raster pattern using a magnetically deflected electron beam inside the X-ray tube. In RGX this large X-ray scanning system is combined with a small detector as shown in Fig. 1. Objects placed near the source scatter X-rays which then bypass the small detector. The direct beam is preferentially detected and results in an image which is not blurred by scattering.

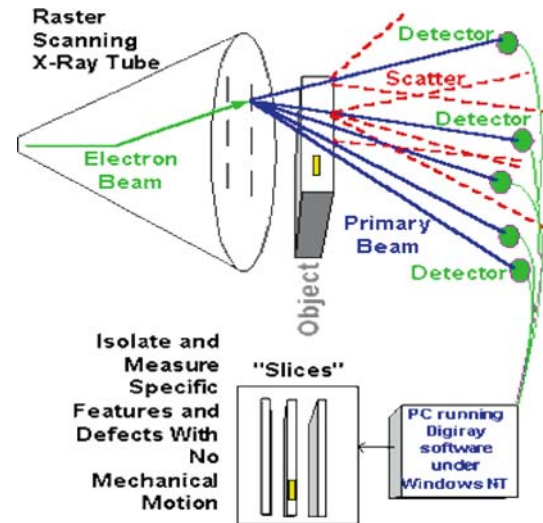
**Fig. 2** In motionless X-ray laminography, the single detector is replaced by an array of small detectors, each being exposed to X-rays

In MLX, the single detector is replaced by an array of 64 small detectors, which are simultaneously exposed to X-rays as shown in Fig. 2. Each detector generates a sharp “unblurred” image at a different angle which is then digitized and stored in the computer. Then each image is shifted with respect to every other image and all are added together. This generates slices, giving a layer-by-layer view of the object. There are no moving parts to degrade the image resolution. In a single short X-ray exposure it captures 1,000 X-ray slices that are 1 pixel thick with 8 mils resolution. These slices can be displayed individually or in a consecutive layer-by-layer motion picture.

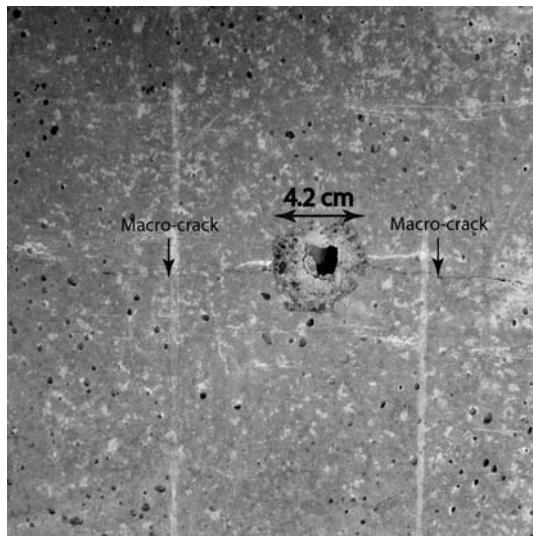
(a) Front face

**Fig. 3** Damage of front and back face in the plain concrete sample (PC)

Figures 3 and 4 depict the damage induced on the front and back face of the plain and PP reinforced concrete panels. In plain concrete panels, spalling occurred from the front face (Fig. 3a). A deep crater formed on the back face (Fig. 3b) due to removal of concrete material. The crater formation was accompanied by debris flying off the back face at a speed of 8 m/s. The depth of the crater is 20 mm. The non-uniform size of the crater reflects the non-uniform micro- and macrostructure of concrete due to the size gradation of coarse and fine aggregates. Through-thickness radial cracks are also present and indicated by arrows in Fig. 3a and b. Figure 4 depicts the concrete panel protected by PP fabric

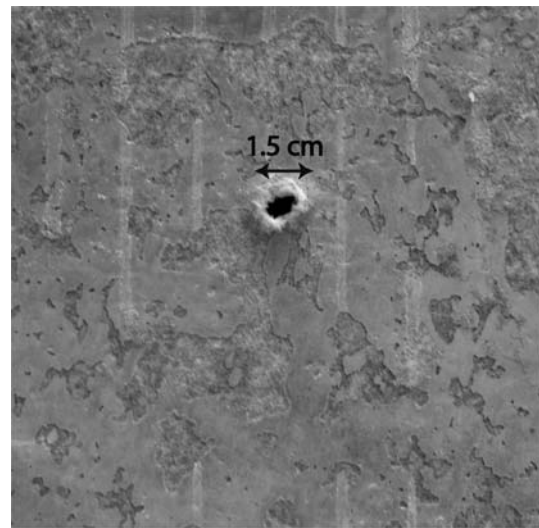
(a) Front face

**Fig. 4** Damage of front and back face in the sample protected by Polypropylene fabric (PP)

on both sides. The fabric prevented spalling from the front face hence the damaged region is smaller compared to the plain concrete panel. A bulge formed on the back face but the fabric remained intact and the bullet was stuck in the concrete panel. Since the damage to the concrete is obscured by the presence of the fabric the damage was analyzed by MLX as will be discussed below.

different depths along the thickness of the panel. The first image (top left in Fig. 5) corresponds to the front surface of the panel (also shown in Fig. 4a). The last image (bottom right in Fig. 5) depicts the damage of the back face (also shown in Fig. 4b). All the images are 12.4 cm × 12.7 cm. Within each image the brightness varies according to the X-ray absorption. Dark regions correspond to low-density regions (e.g., cracks and defects) and light regions show the high-density phases. No through-thickness radial cracks developed in these concrete panels but various types of damage to the concrete can be discerned from Fig. 5. The almost spherically shaped black hole represents the removal of material caused by the penetrating projectile. The size of the black hole in the first image in Fig. 5 is equivalent to the dimension indicated in Fig. 4a. The

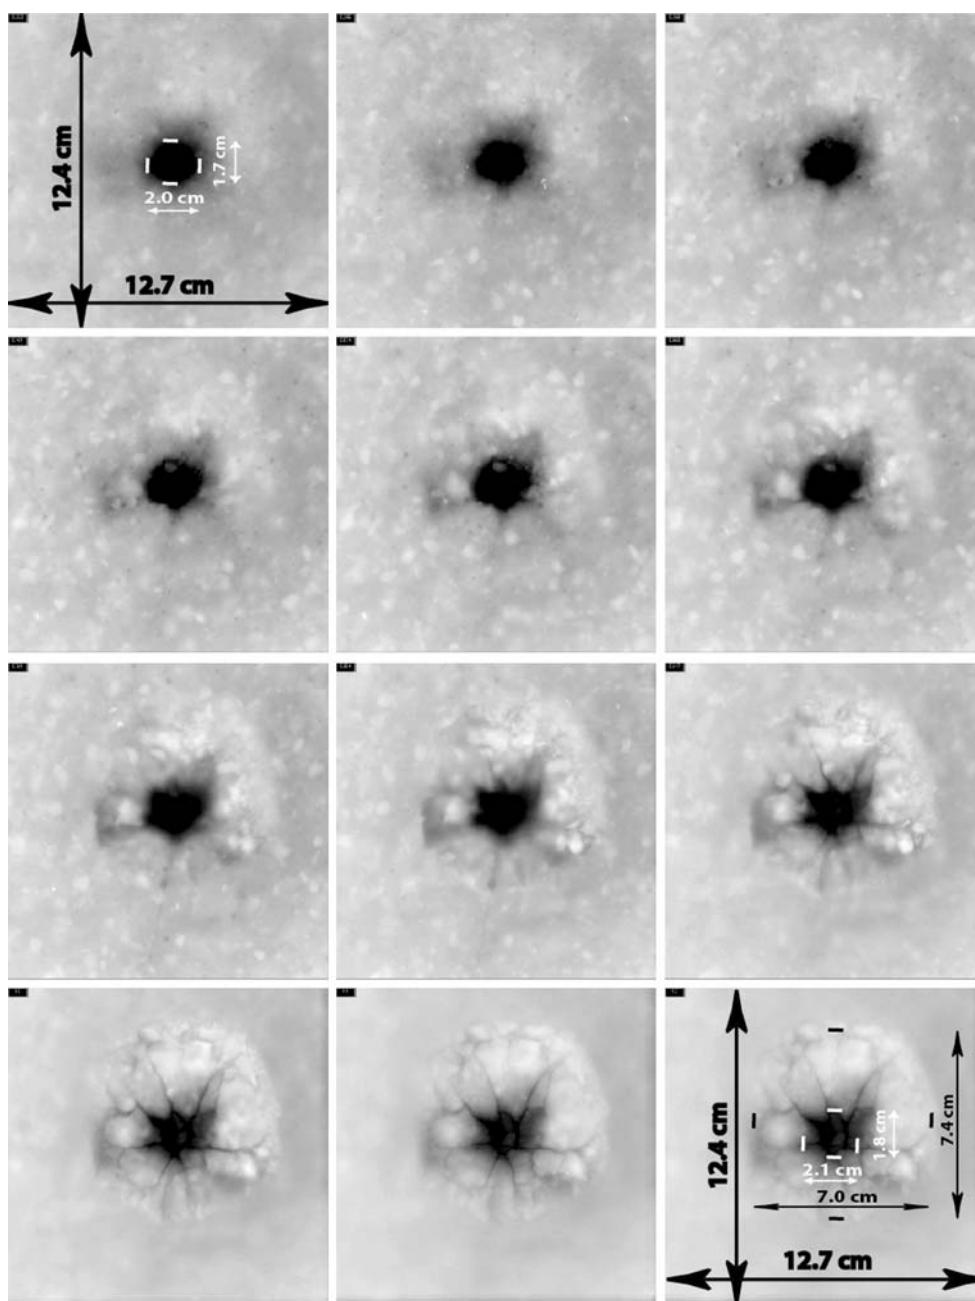
**Fig. 5** The sequence of damage in the concrete panel protected by Polypropylene fabric

The MLX method provides the ability to look through the concrete panel layer by layer providing information on the extent of damage at different layers along the thickness of the concrete panel. Figure 5 depicts the evolution of damage in PP reinforced panels with images taken at

damage to the back face due to impact loading is shown in the last image in Fig. 5. The size of the damaged region detected by MLX corresponds to the size of the bulge in the PP fabric shown in Fig. 4b. The MLX technique reveals radial cracks emanating from the hole created by the projectile. Whereas in plain concrete panels a deep crater formed on the back surface (see Fig. 3b) due to the removal of concrete material, no such crater formed in PP reinforced concrete panels. Otherwise, the circumferential

separation between removed and intact matrix material would show up as dark regions with the MLX technique. Some hairline circumferential cracks are evident at the back face in Fig. 5 but the cracks are discontinuous. With respect to damage evolution due to impact loading, radial crack formations seem to precede crater formation. Such information is critical for the development of damage models. The MLX technique also provides information on the severity of damage through the thickness of the con-

crete panel. The largest damage is observed on the back surface and decreases towards the front face. The radial cracks observed on the back face decrease in length and number with increasing distance away from the back face. No damage (except for the hole left by the projectile) is visible after a distance of 18 mm away from the back face.

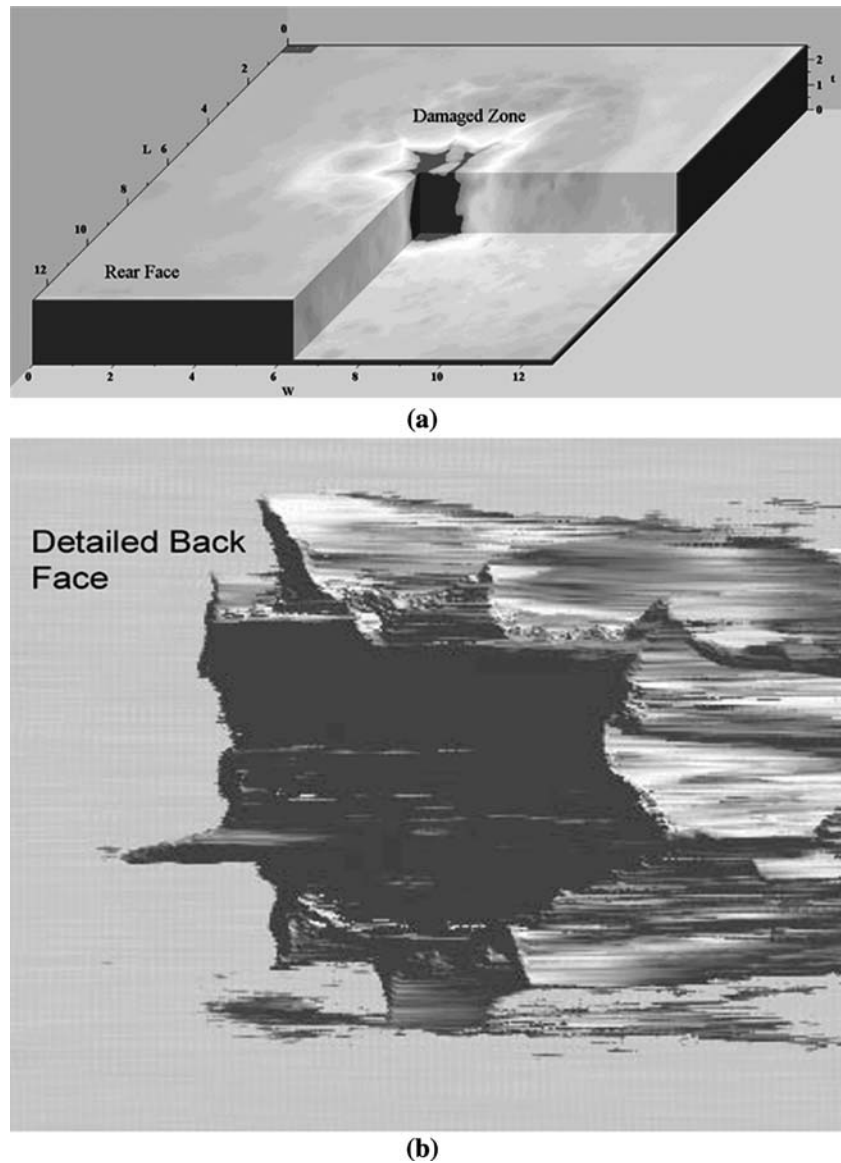
**Fig. 6** 3D views of damage in concrete panel protected by Polypropylene fabric; (a) along the thickness of the panel; (b) damage at the back face

3D-reconstruction was performed with image J [7] using the images along the thickness of the concrete panel shown in Fig. 5. Figure 6 shows the 3D view of the PP reinforced concrete panel. A block was cut out to show the extent of damage along the thickness of the panels (see Fig. 6a). The damage of the back face in 3D is shown in Fig. 6b. Again, it is clearly observed that the damage becomes more significant when approaching the back face.
